# Above the Flood: Elevating Your Floodprone House

FEMA 347/ May 2000

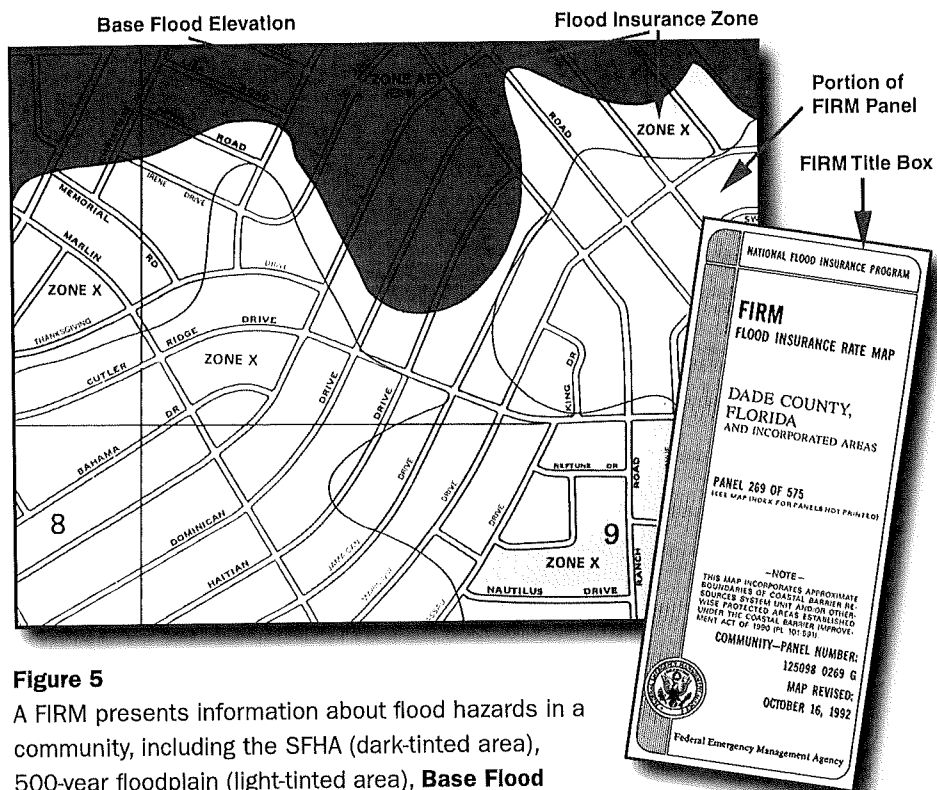
**Figure 5**

A FIRM presents information about flood hazards in a community, including the SFHA (dark-tinted area), 500-year floodplain (light-tinted area), **Base Flood Elevations**, (BFEs) (number in parentheses), and flood insurance zones (AE and X in this example).

Note that the SFHA in the example in Figure 5 is designated Zone AE. This zone is only one of several applied to SFHAs under the NFIP, including V, VE, V1-V30, A, AE, A1-A30, AO, and AH. These zones indicate differences in the types and severity of flood hazards in SFHAs. For the purposes of this publication, it is sufficient to focus on the basic differences between the two main types of SFHA zones—V zones and A zones. The distinction is important because regulatory requirements associated with V zones and A zones differ significantly. As explained later in this chapter, these requirements affect the types of building elevation techniques that may be used under the NFIP.

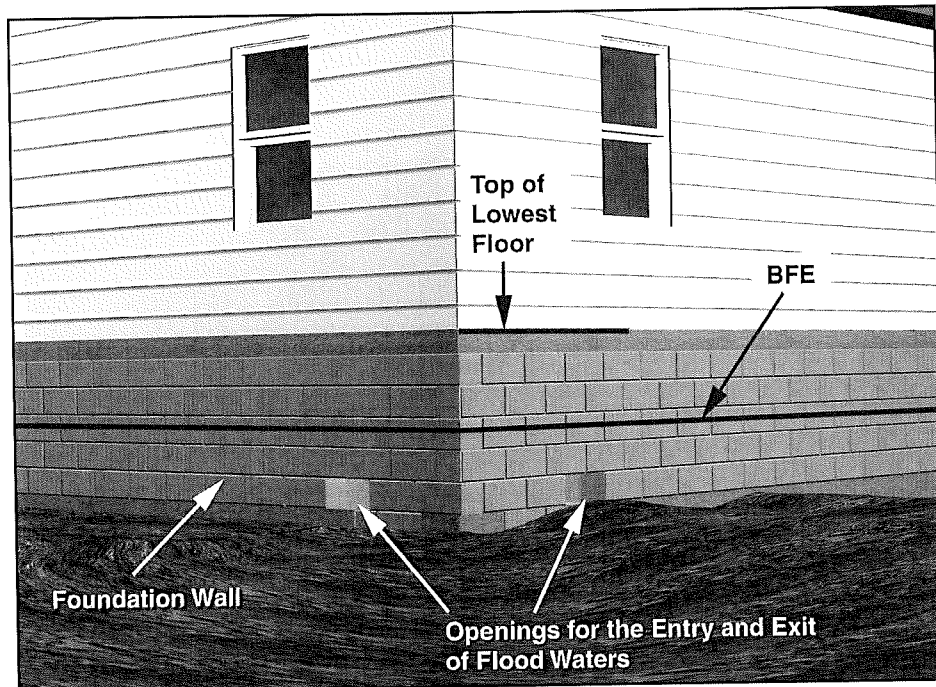
**Figure 6**

In a new, substantially improved, or substantially damaged building in an A zone, the elevation of the lowest floor must be at or above the BFE.

In A zones, where flood hazards are less severe, buildings may be elevated either on an open foundation or on continuous foundation walls below the BFE (Figure 6). Regardless of the type of foundation used, A-zone buildings must be elevated so that the **lowest floor** is at or above the BFE, as shown in Figure 6. If continuous walls are used below the BFE, they must be equipped with openings that allow flood waters to flow into and out of the area enclosed by the walls (Figure 6). Allowing the entry and exit of flood waters ensures that water pressures will be the same on both sides of the walls and reduces the likelihood that water pressure will cause the walls to fail.

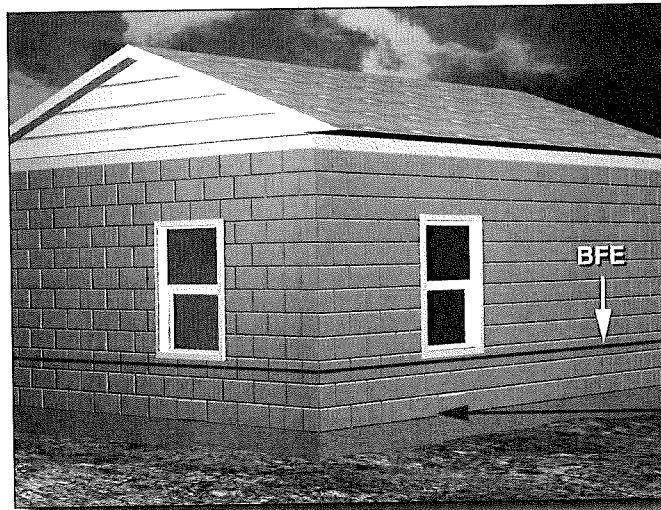
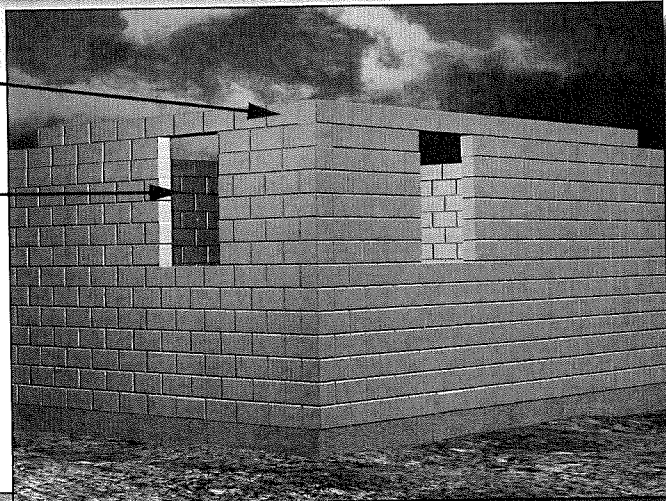
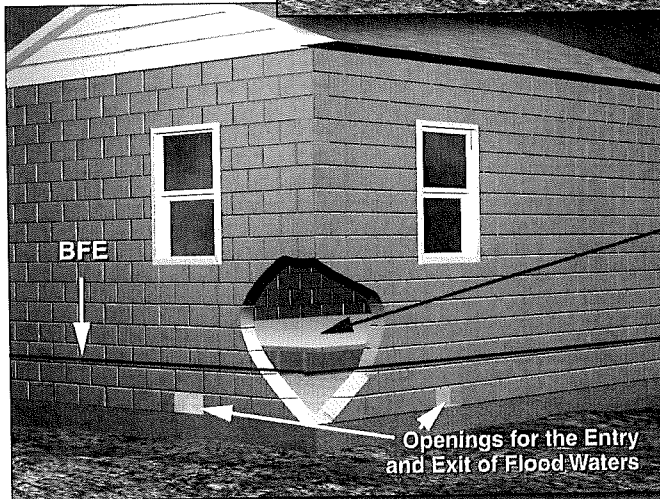
**Figure 7**

Technique 1 –  
Extend the walls of  
the house upward and  
raise the lowest floor.

House at the time  
Hurricane Andrew  
struck

Extended Walls

Raised Window  
Opening

Substantially damaged house undergoing  
repairs that will bring it into compliance  
with Miami-Dade County floodplain  
management requirements

New,  
Raised Floor

House after  
completion of repairs

Openings for the Entry  
and Exit of Flood Waters

1. Extend the walls of the house upward and raise the lowest floor (Figure 7).
2. Convert the existing lower area of the house to non-habitable space and build a new second story for living space (Figure 8).
3. Lift the entire house, with the floor slab attached, and build a new foundation to elevate the house (Figure 9).

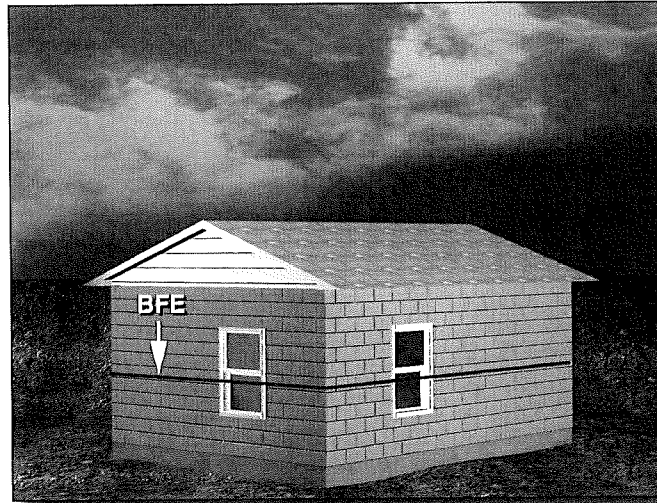
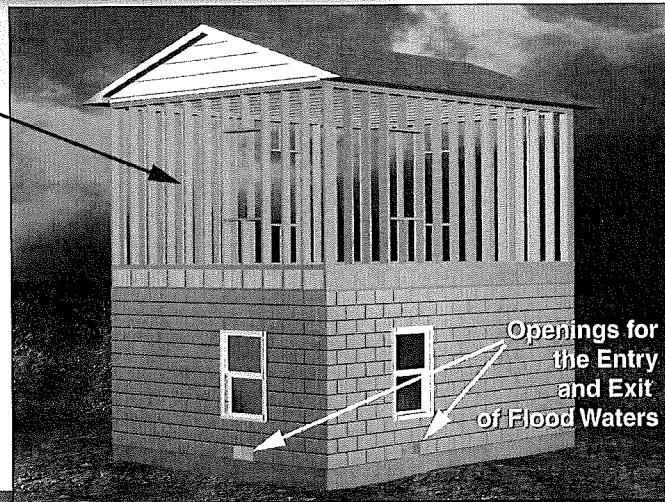
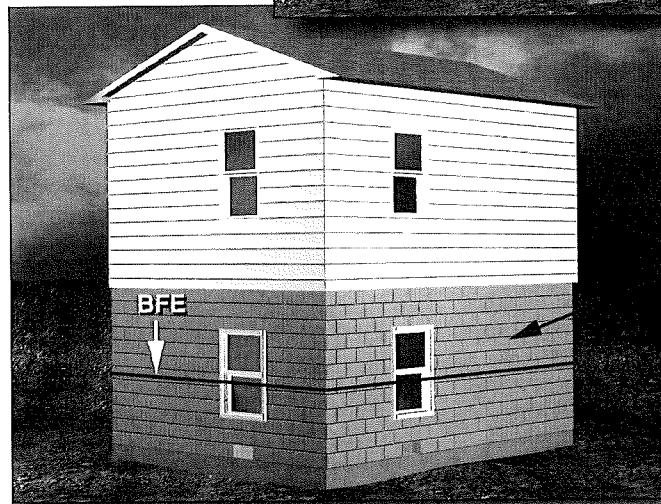
**Figure 8**

Technique 2 –  
Convert the existing  
lower area of the  
house to non-  
habitable space and  
build a new second  
story for living space.

**House at the time  
Hurricane Andrew  
struck**

New Second  
Story Above  
BFE

Substantially damaged house undergoing  
repairs that will bring it into compliance  
with Miami-Dade County floodplain  
management requirements

Openings for  
the Entry  
and Exit  
of Flood Waters

House after  
completion of repairs

Lower Area  
Converted to  
Non-Habitable  
Space for  
Storage,  
Parking, or  
Building  
Access

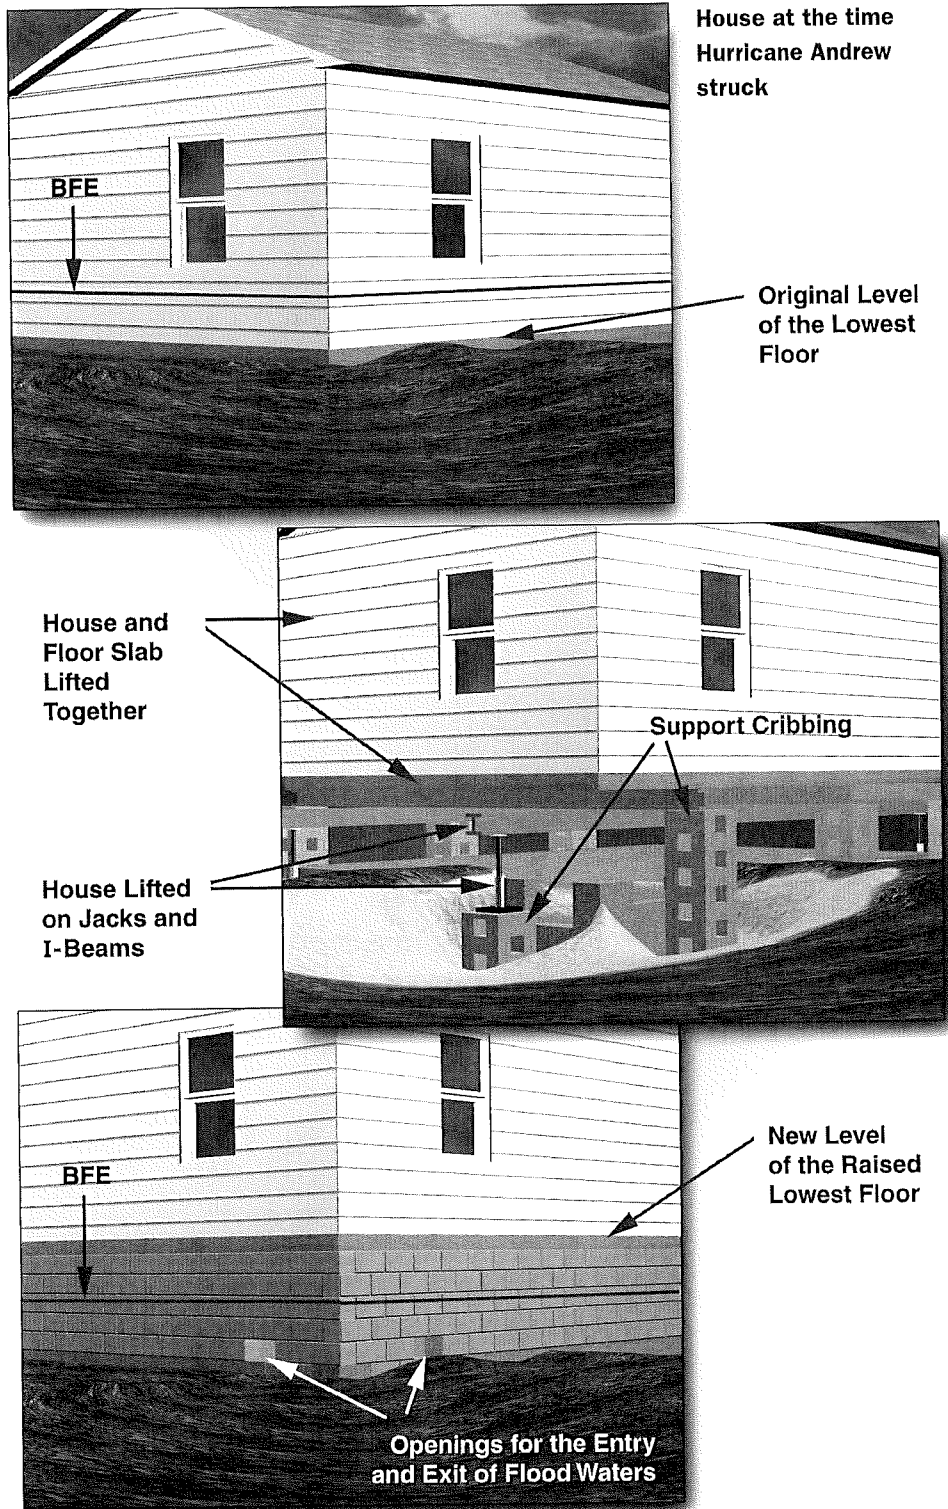
**Figure 9**

Technique 3 –  
Lift the entire house,  
with the floor slab  
attached, and build  
a new foundation to  
elevate the house.

Substantially  
damaged house  
undergoing repairs  
that will bring it  
into compliance  
with Miami-Dade  
County floodplain  
management  
requirements

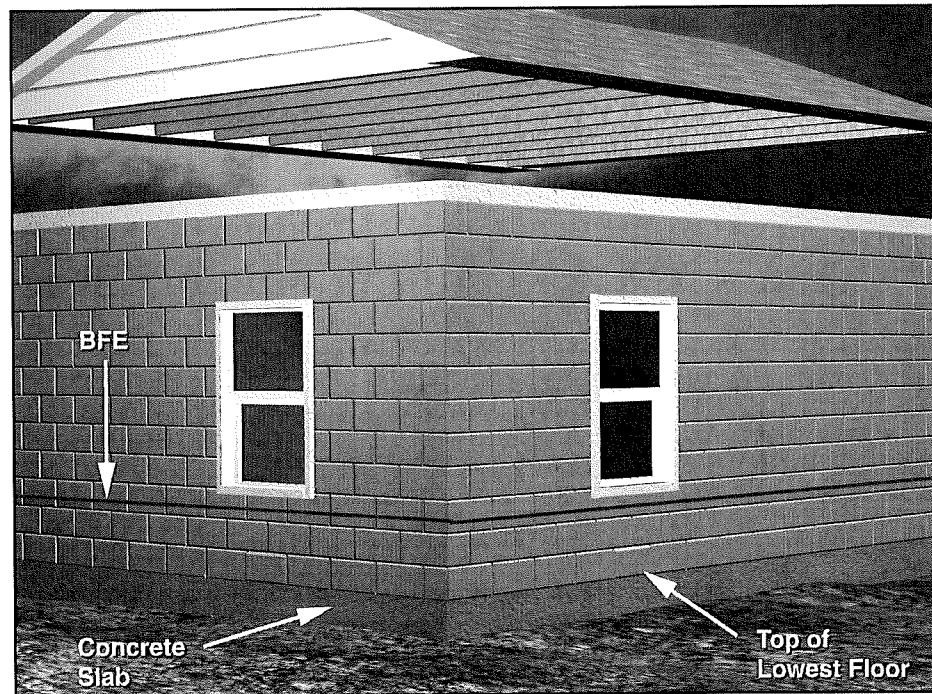
**Figure 10**  
The first step in Technique 1 is removing the roof.

Technique 1 is appropriate for houses with concrete or masonry walls, but not for houses with other types of walls, such as those framed with wood studs, which would be more vulnerable to flood damage. This technique is usually appropriate when the depth of the base flood at the house is no more than 4 or 5 feet above grade. The elevation process begins with the temporary removal of the roof and roof framing, in a single piece if possible (Figure 10). This is commonly done with a crane. The roof is then stored on site so that it can be reinstalled later. The next step is to remove the windows and doors.

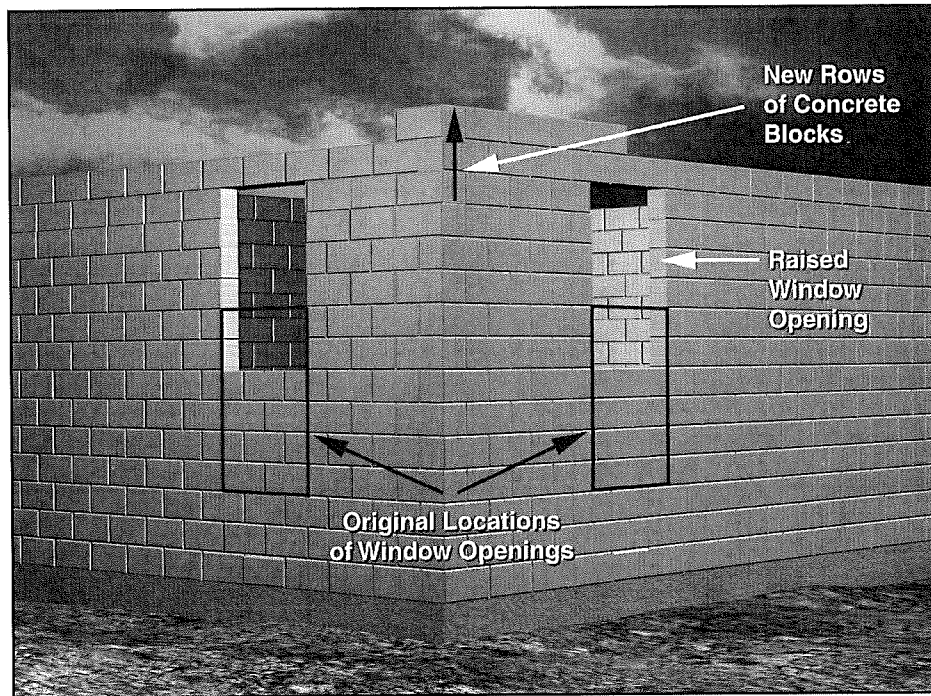
**Figure 11**

After the roof, windows, and doors are removed, several courses of concrete block are added to the tops of the existing walls and to the bottoms of the window openings (Figure 11). A corresponding number of blocks are removed from the tops of the window openings so that the size of the windows will remain the same. In addition, although not shown in Figure 11, concrete bond beams are formed in place at the tops of the extended walls to provide structural reinforcement.

The tops of the walls and bottoms of the window openings are raised with concrete blocks.

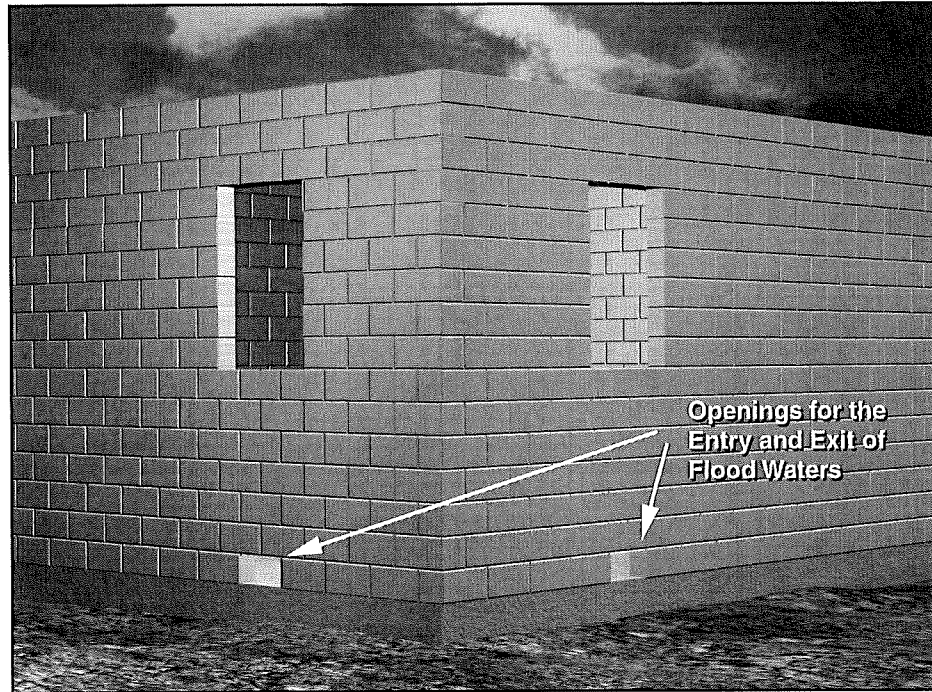
Blocks are removed from the walls of the house at selected locations within 1 foot of the ground (Figure 12). The resulting openings will allow flood waters to flow into and out of the lower area of the house so that the water pressures on both sides of the walls will remain the same. The roof and windows are then replaced, and a new wood-frame floor is constructed above the flood level (Figure 13).

**Figure 12**  
Openings are created  
in the walls near the  
ground.

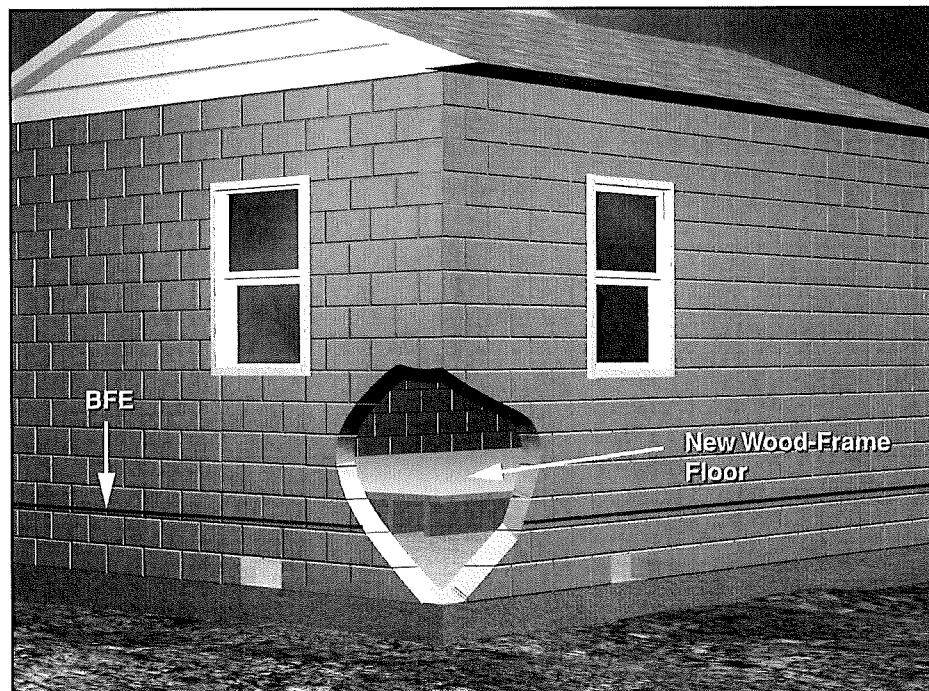
**Figure 13**  
A new wood-frame  
lowest floor is  
constructed above the  
flood level, and the  
roof, windows, and  
doors are reinstalled.

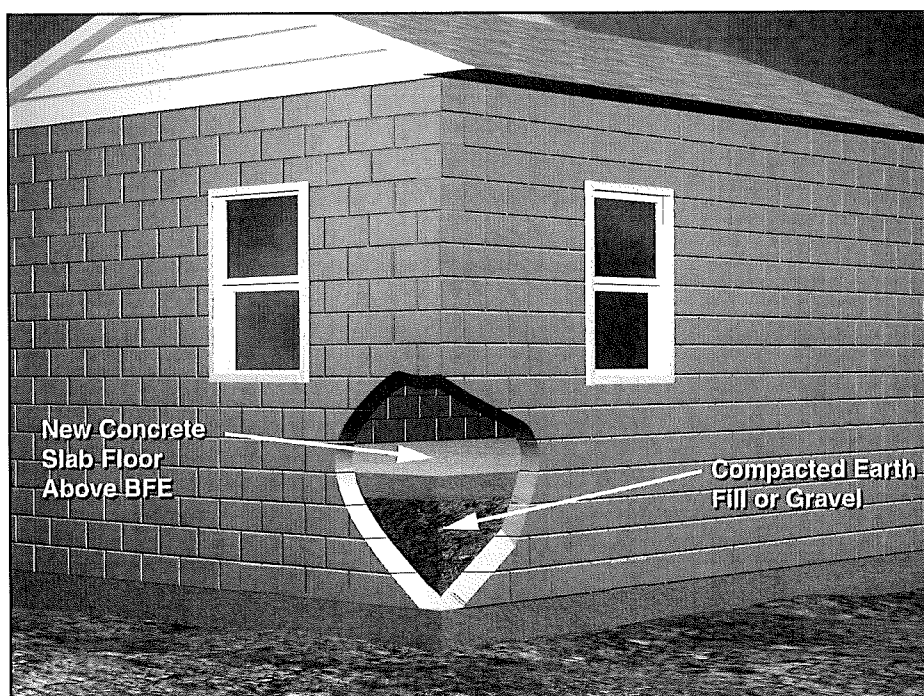
A homeowner who chooses Technique 1 may decide to build a new concrete slab floor instead of a wood floor (Figure 14). When this option is chosen, compacted fill dirt or gravel is placed on top of the old slab and the new slab floor is poured on top. Because the area below the new floor is filled with dirt or gravel, wall openings are not required.

**Figure 14**  
An alternative to building an elevated wood-frame floor is installing a new, elevated concrete slab floor on fill placed over the old slab.

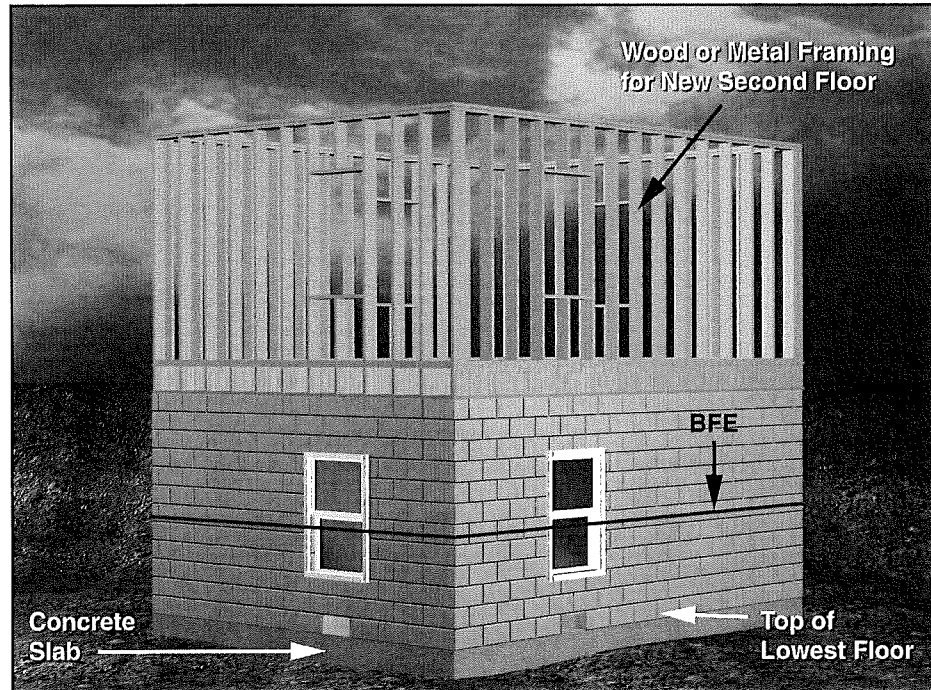
As in Technique 1, the repairs begin with the temporary removal of the roof and roof framing (Figure 10). After the roof is removed, construction of the new second story begins. First, a new wood-frame floor is built on top of the existing lower-story walls. The second-story walls are framed with metal or wood studs and set in place on the floor (Figure 15).

**Figure 15**  
The new second-story floor and walls are built on top of the existing lower story.

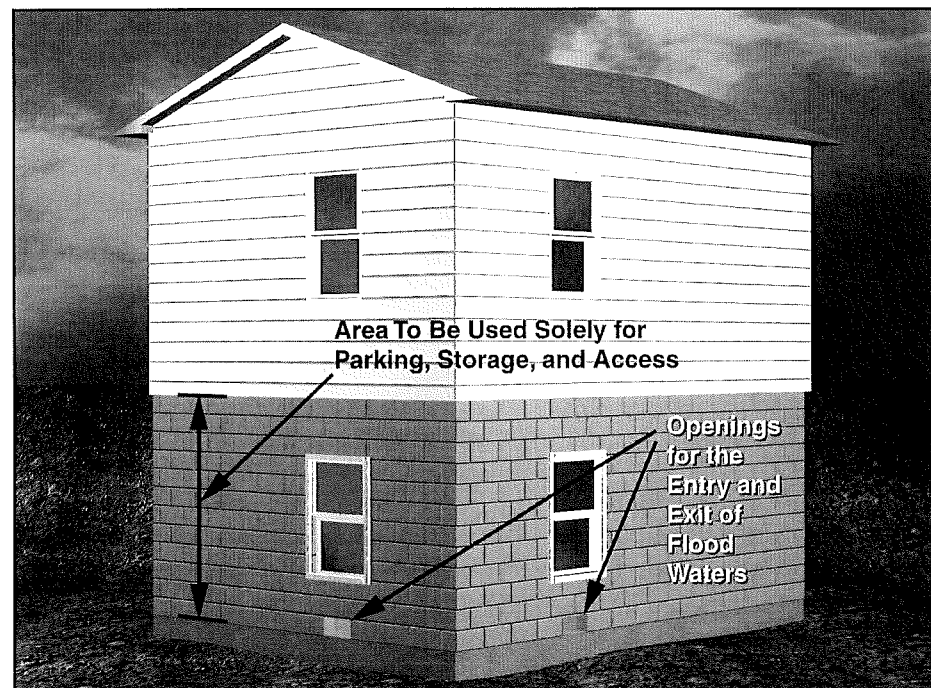
Some homeowners prefer that the second story be constructed of masonry, but wood- or metal-framing is more common, primarily because it is lighter and less expensive. The roof is replaced, and blocks are removed from the walls to allow flood waters to enter and exit. Exterior sheathing is then added to the framed walls of the second story, the new windows are installed, and siding or stucco is applied to the sheathing (Figure 16).

**Figure 16**  
The new second-story walls are covered with siding or stucco.

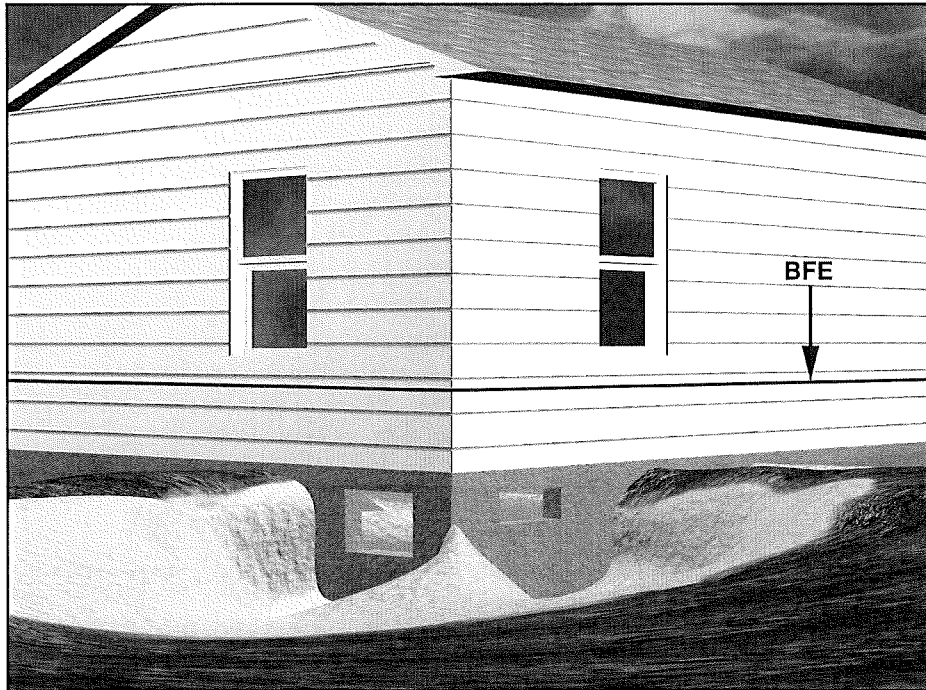
First, trenches are dug to expose the foundation walls immediately below the slab. Holes are then cut in the foundation walls at intervals around the house, and tunnels are dug under the slab (Figure 17). Jacks are placed in the trenches and large I-beams are inserted through the tunnels and allowed to rest on the jacks. Smaller I-beams are then inserted through the tunnels at right angles to the larger beams and positioned on top of them. The smaller beams support the slab when the house is raised (Figure 18).

**Figure 17**  
Trenches and tunnels under the slab provide access for the jacks and I-beams that will lift the house.

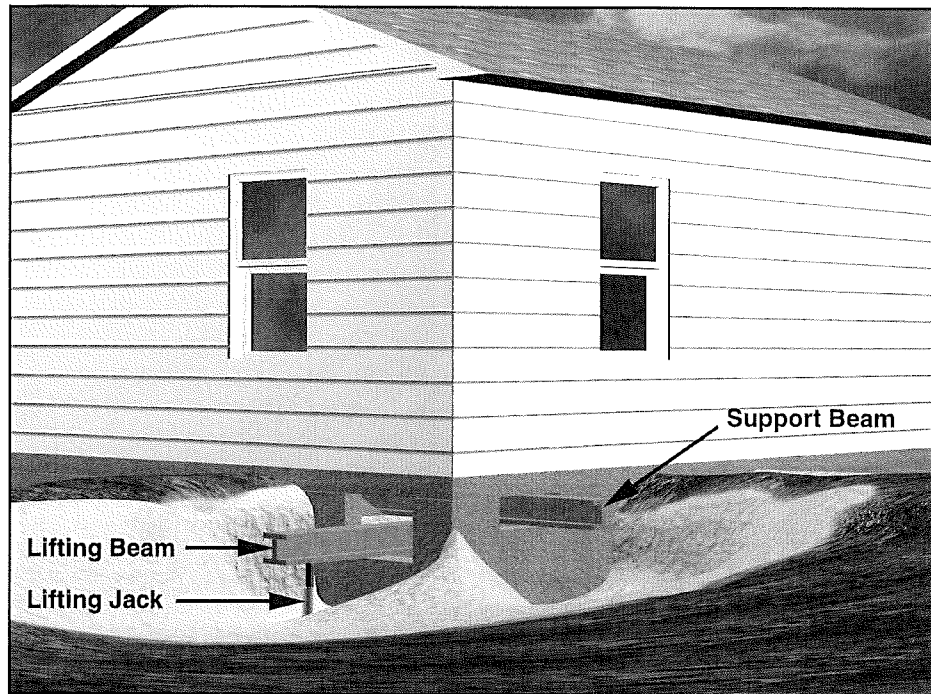
**Figure 18**  
With I-beams and jacks in place, the house is ready to be lifted.

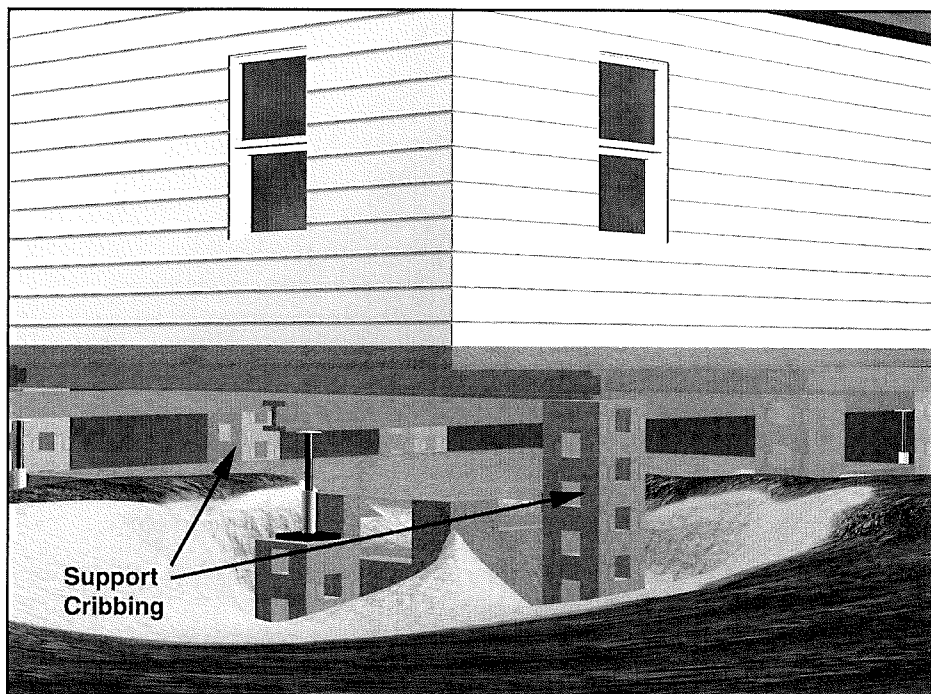
The house is then jacked up. When the jacks have extended as far as possible, the house must be supported temporarily while the jacks are raised. Both the house and the jacks are usually supported on “cribbing”—temporary piles of crisscrossed timbers (Figure 19). The jacks are then used to raise the house higher.

**Figure 19**  
The house is temporarily supported on cribbing.

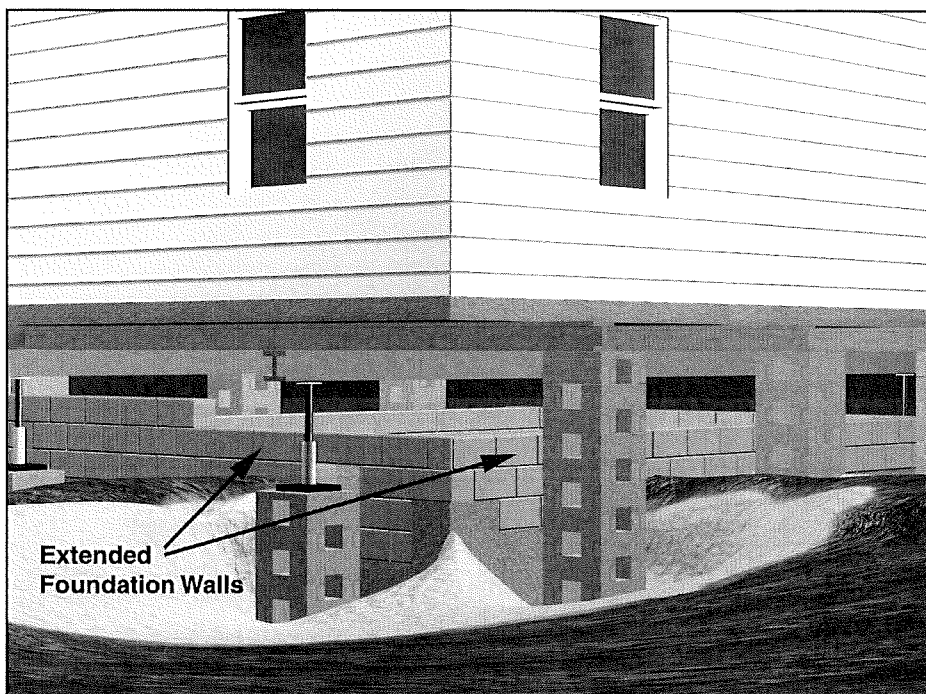
This process is repeated until the house is raised to the desired height. The foundation walls are then extended upward with additional rows of concrete block (Figure 20). As in the previous techniques, openings are made in the walls within 1 foot of the ground so that flood waters will be able to flow into and out of the area below the elevated floor. The jacks and beams are removed, and the openings left around the beams are filled with blocks (Figure 21).

**Figure 20**  
New, extended  
foundation walls are  
constructed with  
concrete blocks.

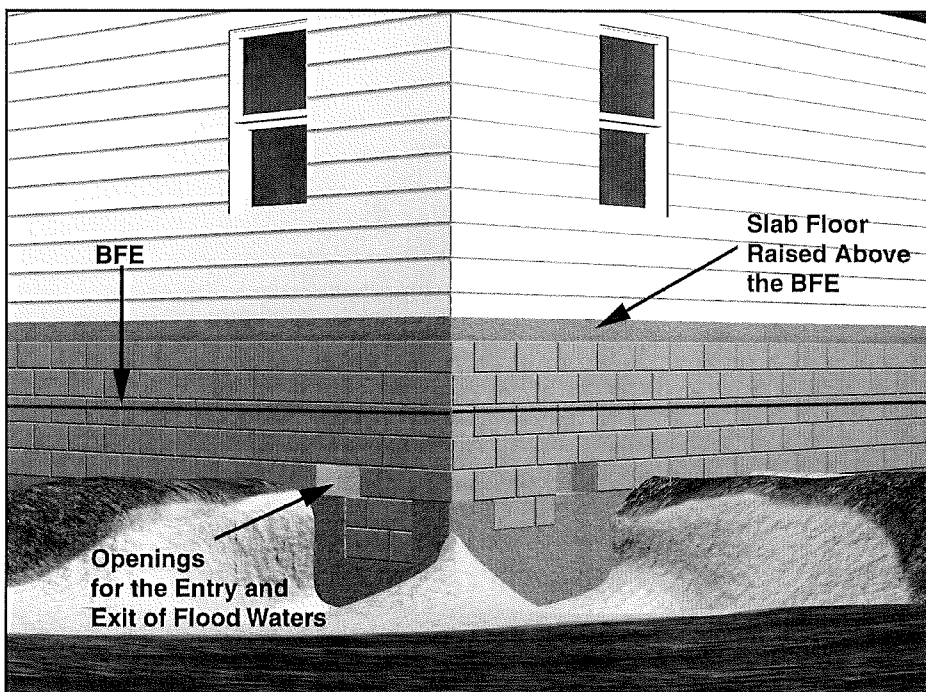
**Figure 21**  
Elevated house and  
slab on new, extended  
foundation walls.
