# Case Studies

*Eight case studies demonstrate how substantially damaged houses were elevated in Miami-Dade County After Hurricane Andrew.*

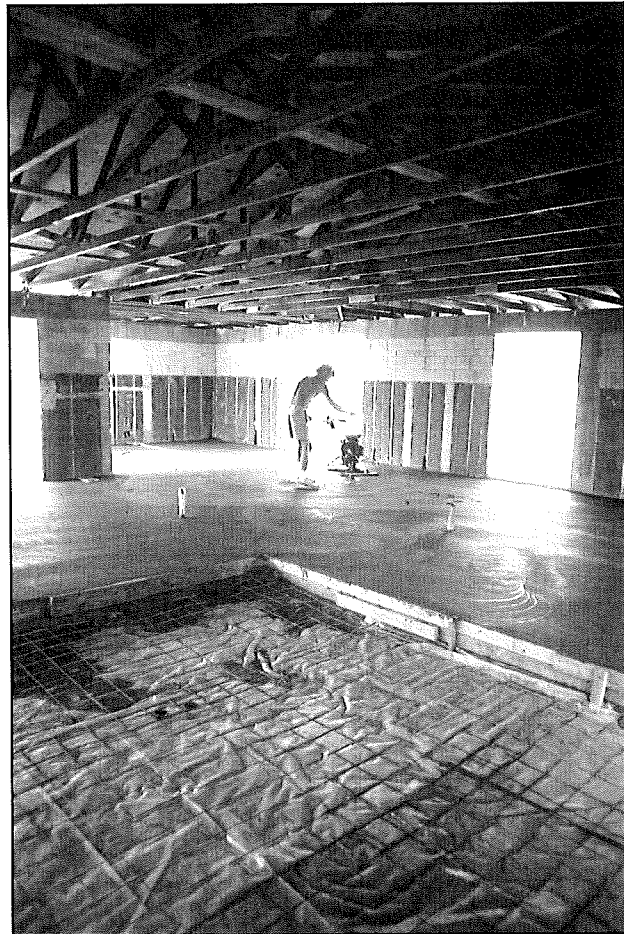
**Figure 26**

The roof has been rebuilt with the salvaged trusses, and most of the new concrete slab has been poured on top of the sand fill. The open area in the foreground, where plastic sheeting and wire reinforcement can be seen on top of the sand fill, is where the remaining part of the slab will be poured.

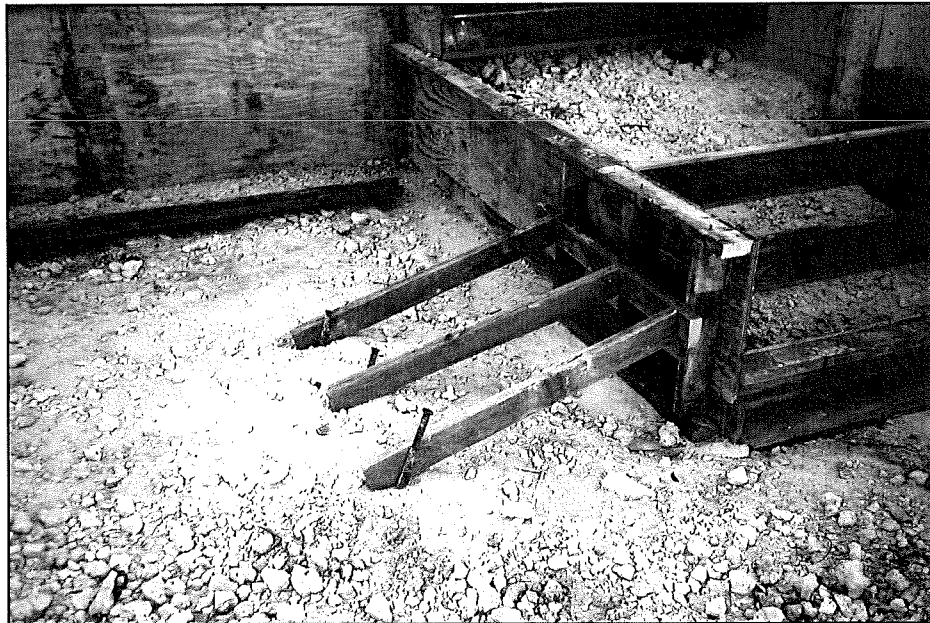
**Figure 33**  
Wood framing for a  
new concrete staircase  
that will provide  
access to the elevated  
floor.

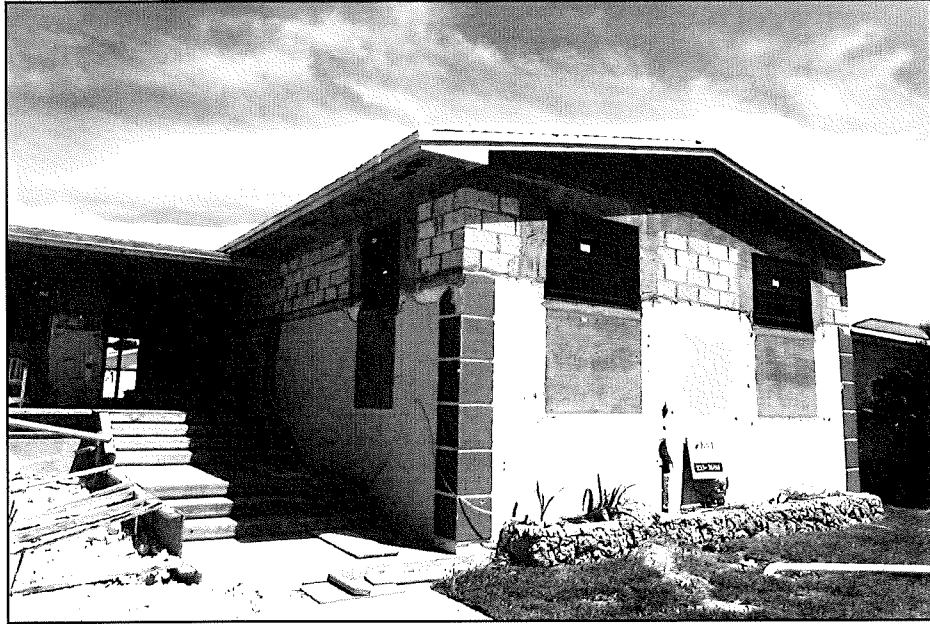
**Figure 36**

In this view from the front of the house, the amount of elevation is shown by the rows of concrete block on the tops of the original walls and by the raised window openings.

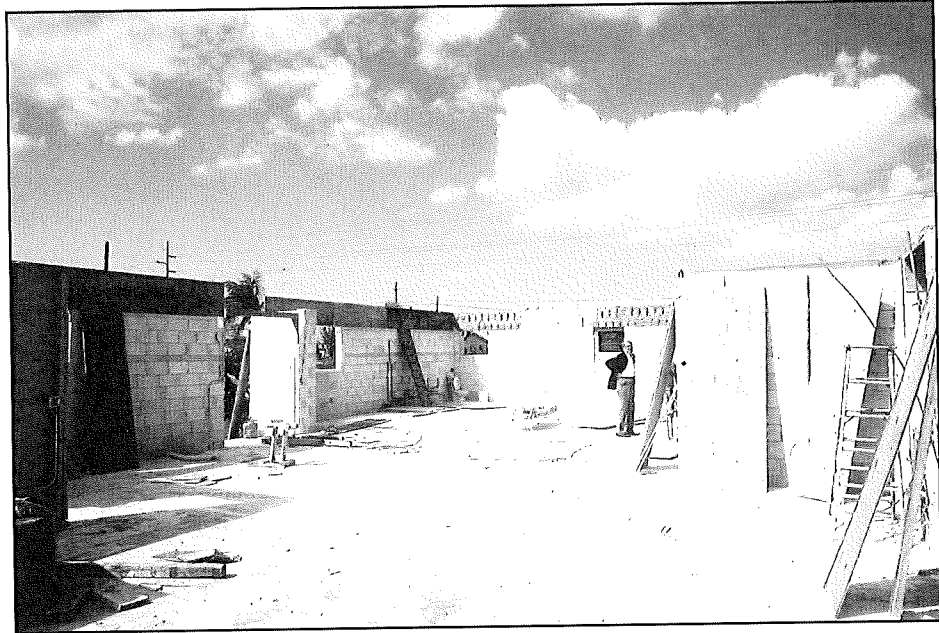
**Figure 40**

After the roof was removed and the storm-damaged interior gutted, the walls of the house were extended upward and a new bond beam added at the top.

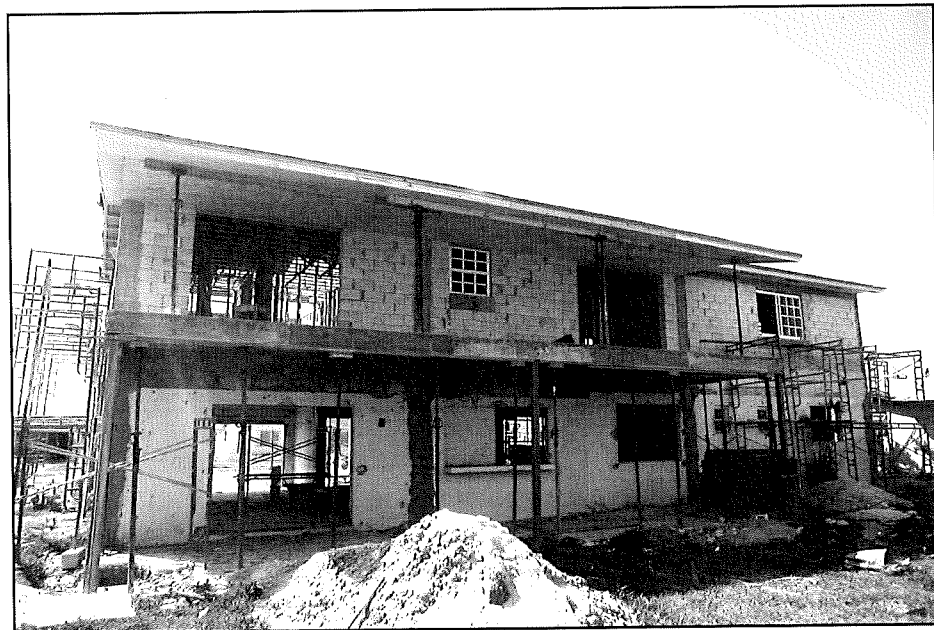
**Figure 47**  
The tiedown columns extend down from the new second-story walls and into the original first-floor walls. The columns tie the first and second stories together and provide a continuous load path that helps the house resist the forces of high winds.

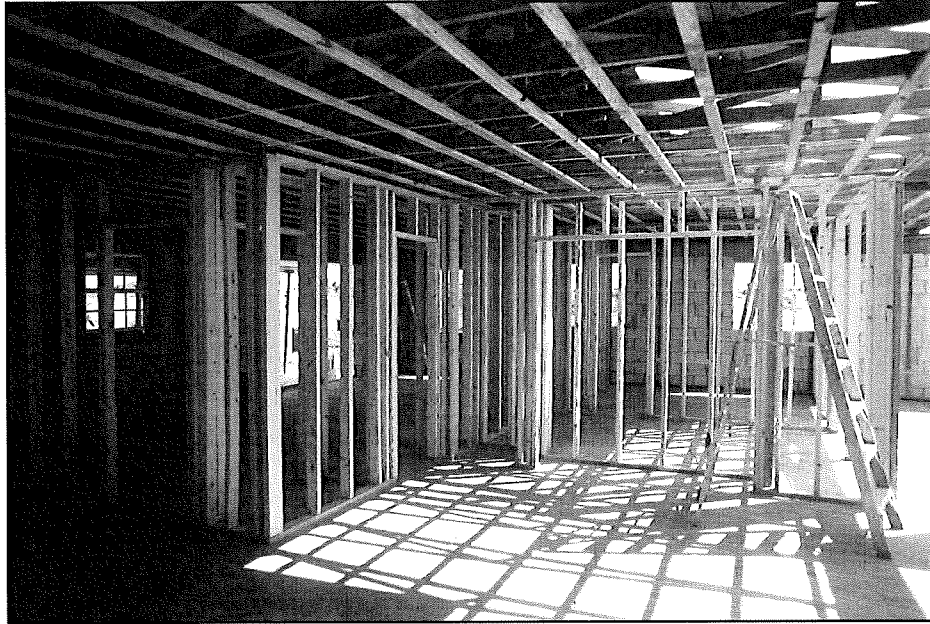
**Figure 48**  
Wood 2 by 4 studs  
were used to frame  
the interior walls of  
the second story.

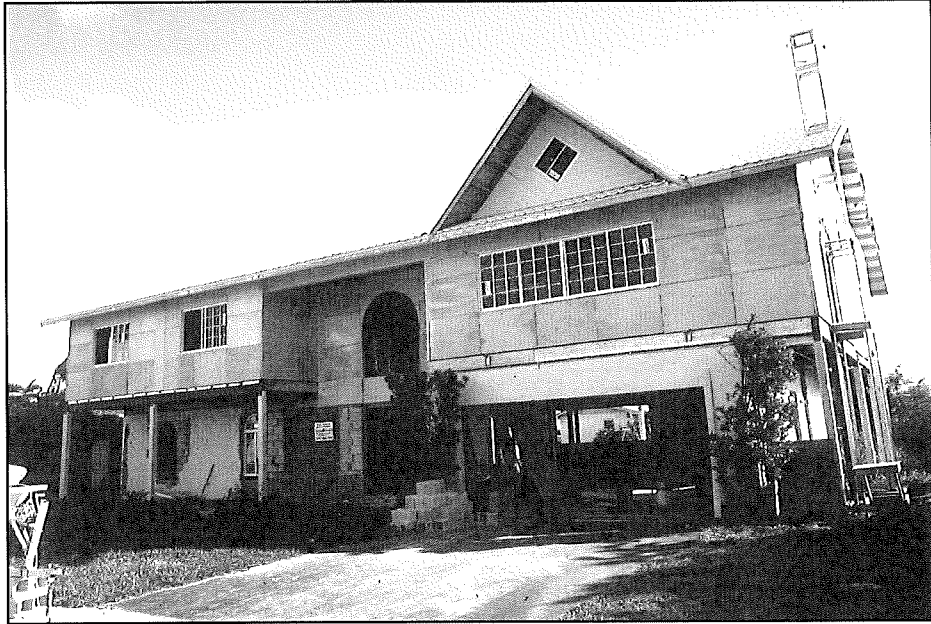
**Figure 58**

The new second story  
nears completion.  
The roof is made of  
formed metal panels.

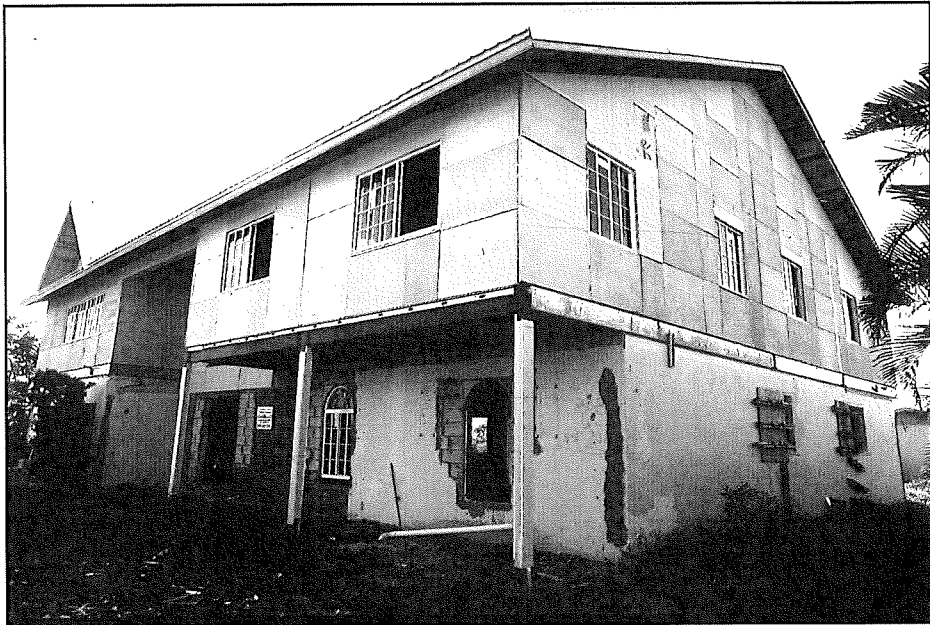
**Figure 59**

The exterior  
walls consist of  
prefabricated  
concrete panels.  
Innovative techniques  
such as those  
employed in this  
project are helping  
homeowners who  
need practical and  
economical methods  
of repairing and  
protecting their  
houses.

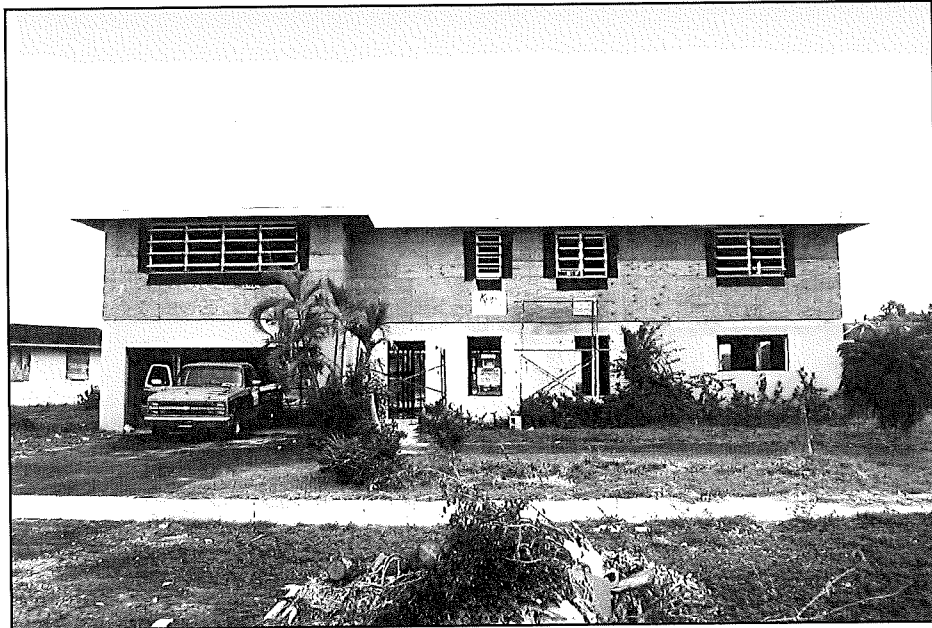
**Figure 62**

After the wood framing was completed, the roof and exterior wall sheathing were added.

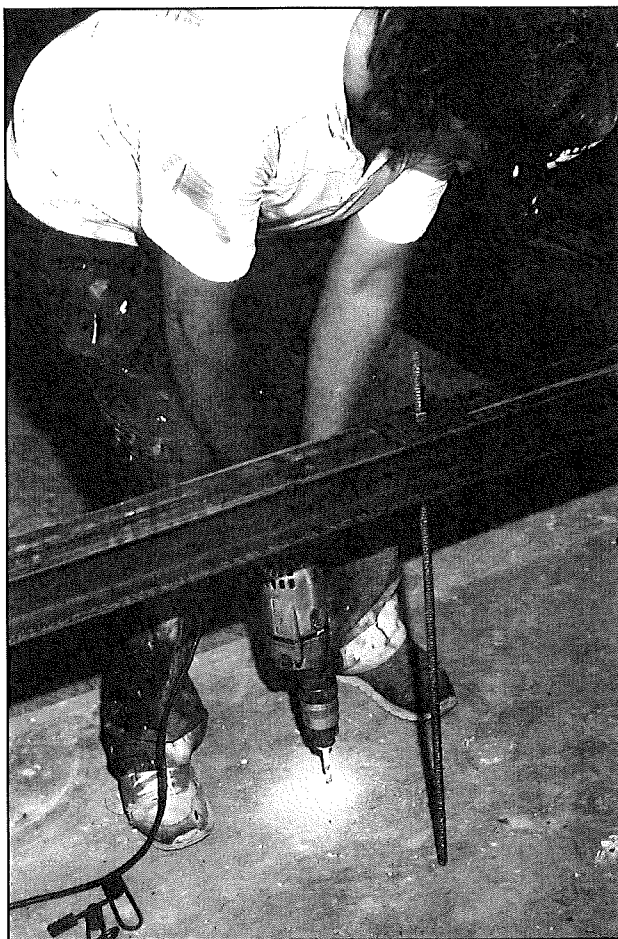
**Figure 76**

Inside the house,  
workers drill holes in  
the concrete slab ...

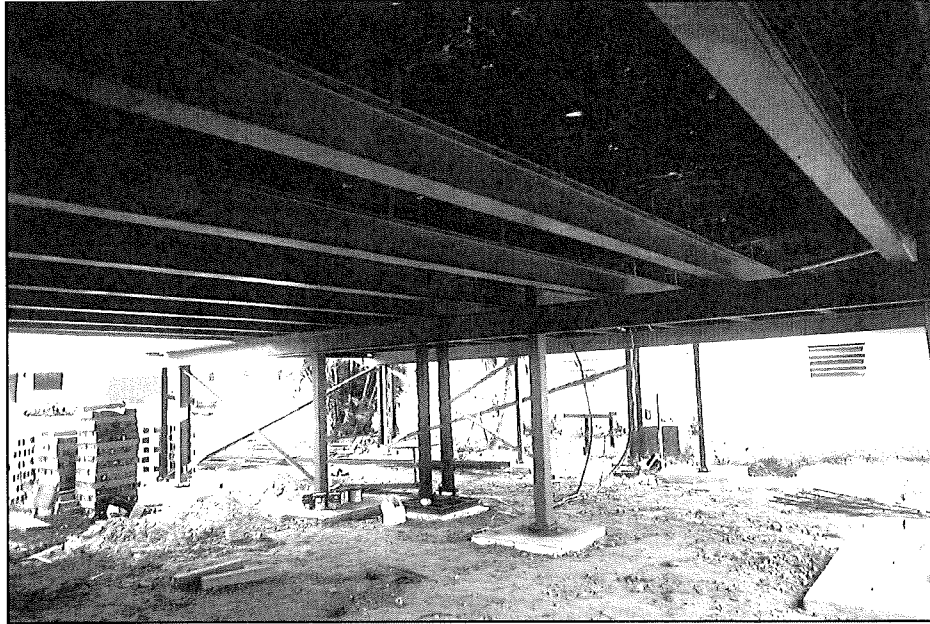
**Figure 82**

While the jacks and beams supported the house, new steel foundation members were installed below.
